Cyclic Fatigue Durability of uncoated and EBC coated 3D SiC/SiC Composites under thermal gradient conditions at 2700F in air

Craig Smith, Bryan Harder, Dongming Zhu
NASA Glenn Research Center, Cleveland, OH

Examination of Sample that Broke During 487 Hour Thermal Gradient SPLCF

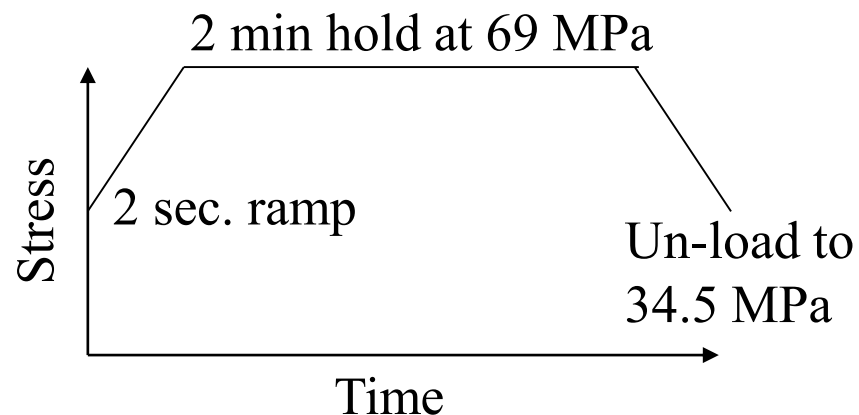
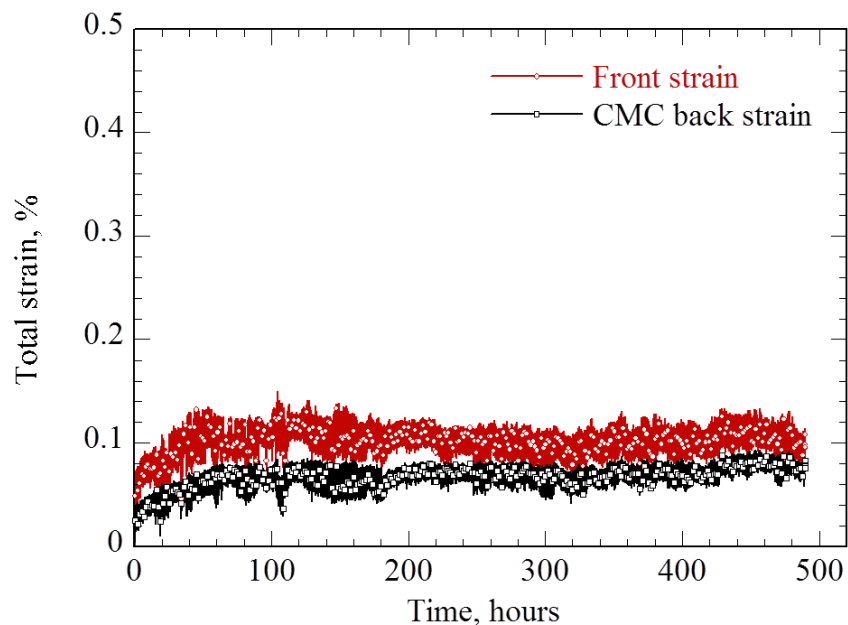
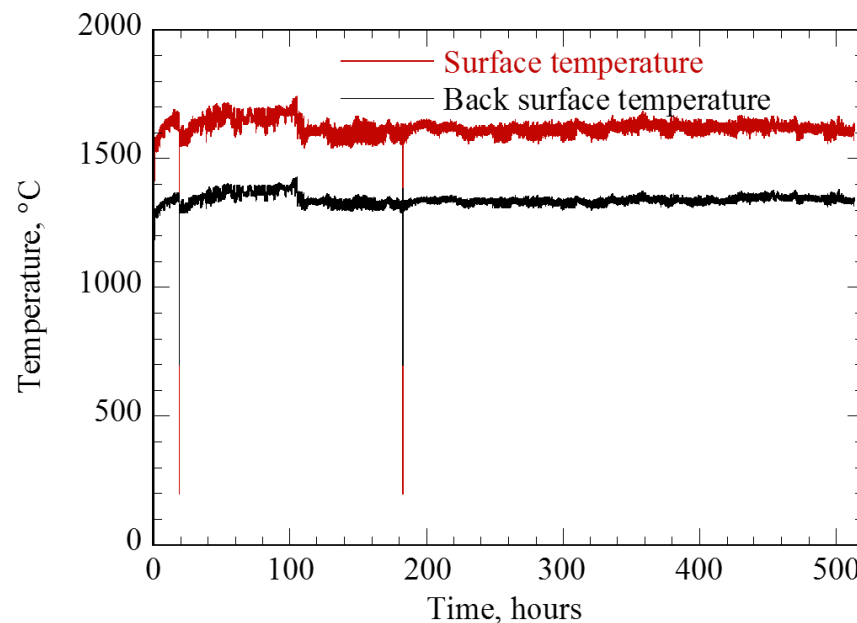
SPLCF Results under Through-Thickness Thermal Gradient

- EBPVD Coated sample
- Average EBC surface temperature: 2950°F
- Average EBC/CMC interface temperature: 2742°F
- CMC back surface temperature: 2442°F
- Maximum EBC surface temperature: >3000°F

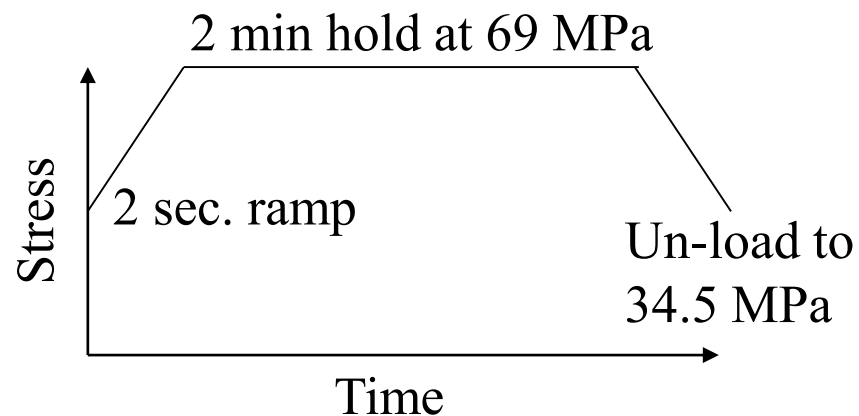
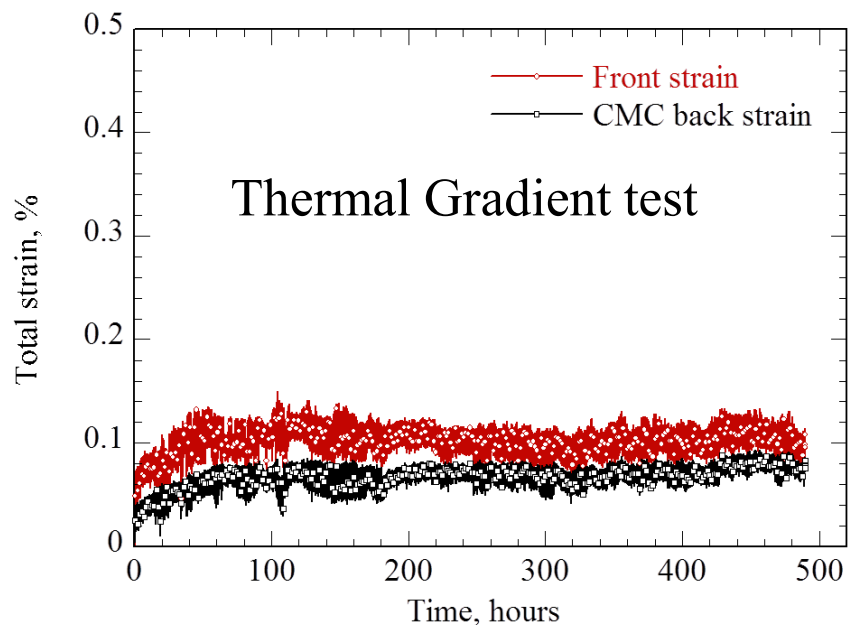
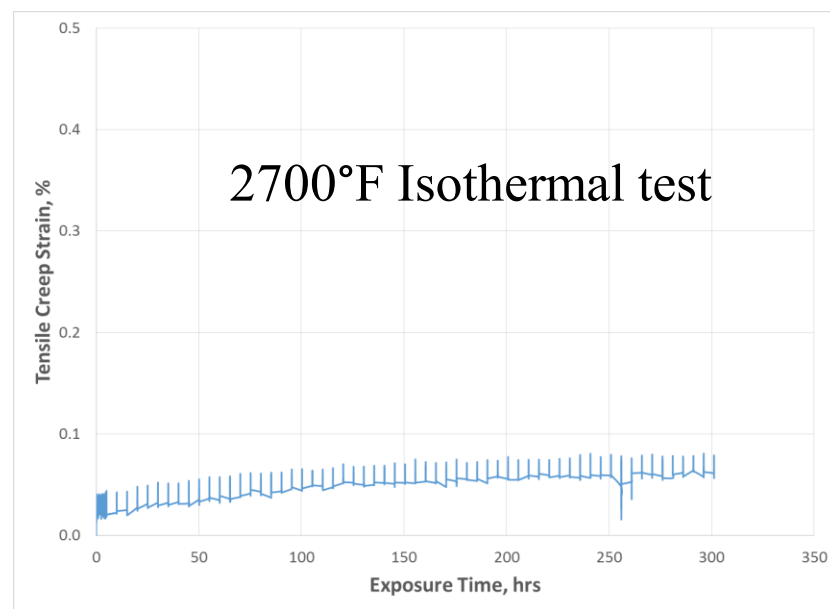
SPLCF Results

- Both CMC samples were the same system (architecture, matrix, bond coat, EBPVD EBC)
- Both loaded with the same stress profile
- 2700°F isothermal temp is similar to the CMC/EBC interface temp (2742°F) for laser test
- Strain of the isothermal sample is expected to be similar to the front strain of the laser sample

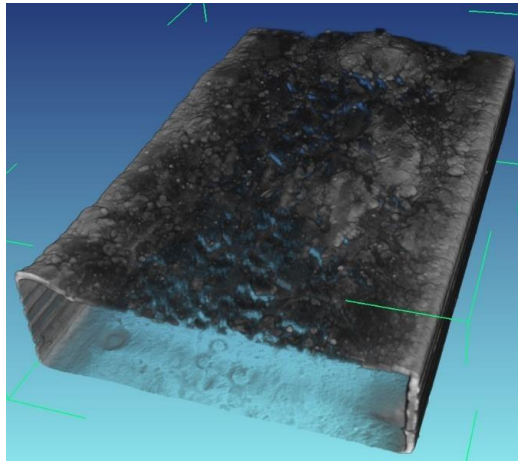
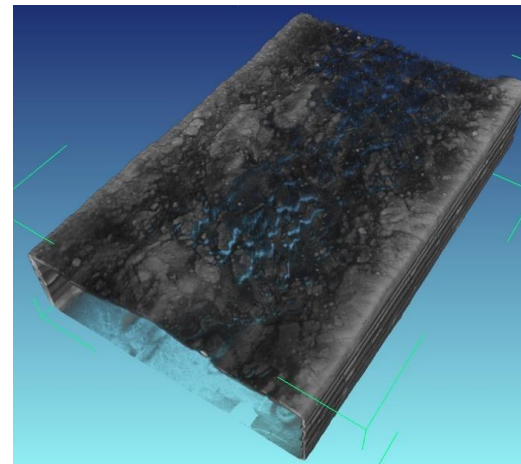
Before Testing- Only EBC Shown

- Thermal gradient tests are relevant for cooled CMCs
- Interpretation of the data is complicated
- CT images of as-produced sample showed regions of thin coatings
- After the 487 hour SPLCF, some areas of the coating were missing
- The sample may have been overheated beyond 3000F (EBC temperature)
- This sample lasted 487 hours under thermal gradient SPLCF
- More tests are underway to evaluate the material
 - Steam exposure, more thermal gradient tests

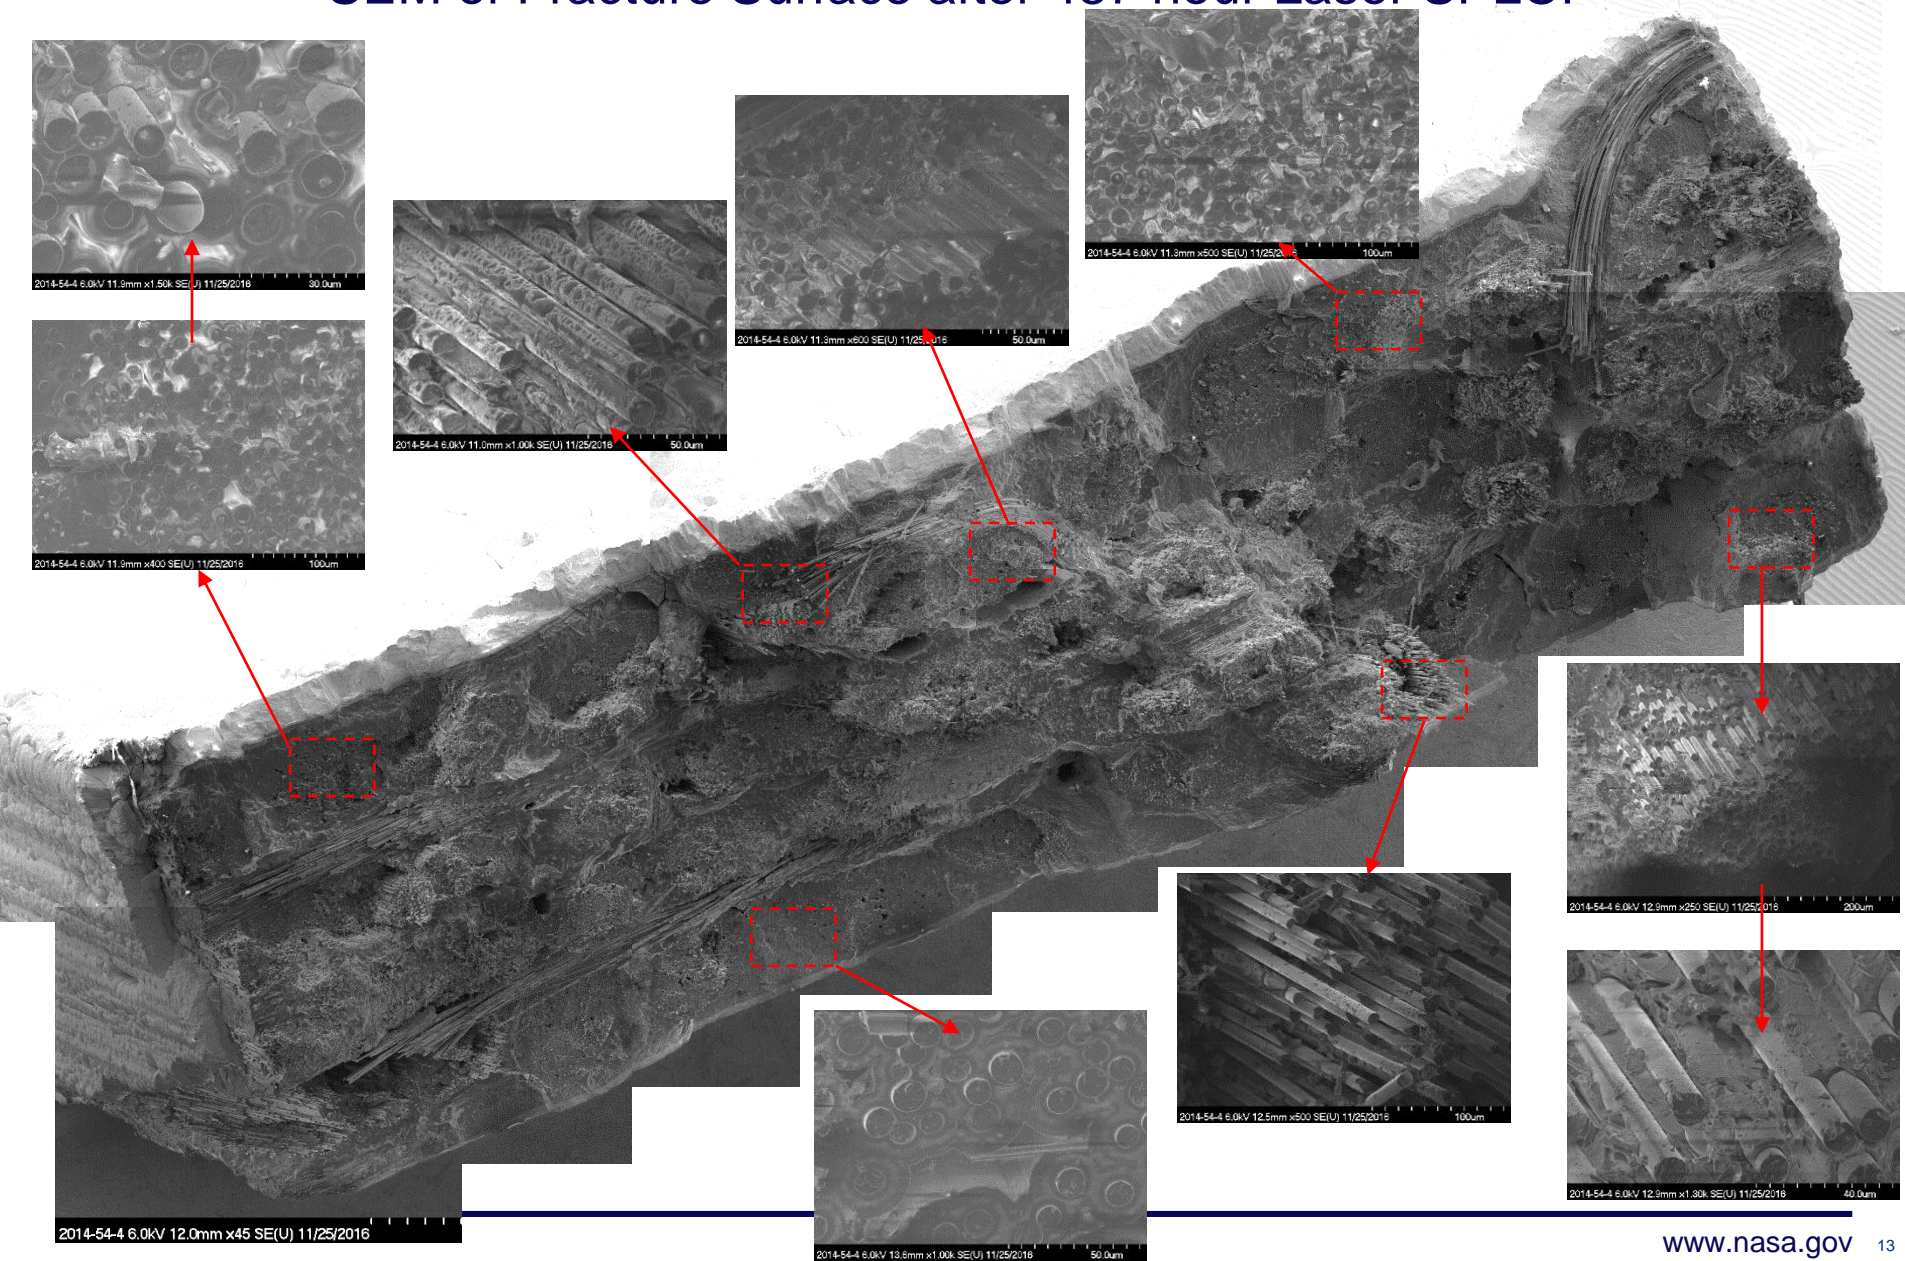
SEM of Fracture Surface after 487 hour Laser SPLCF

- Very flat fracture surface, little fiber pull-out

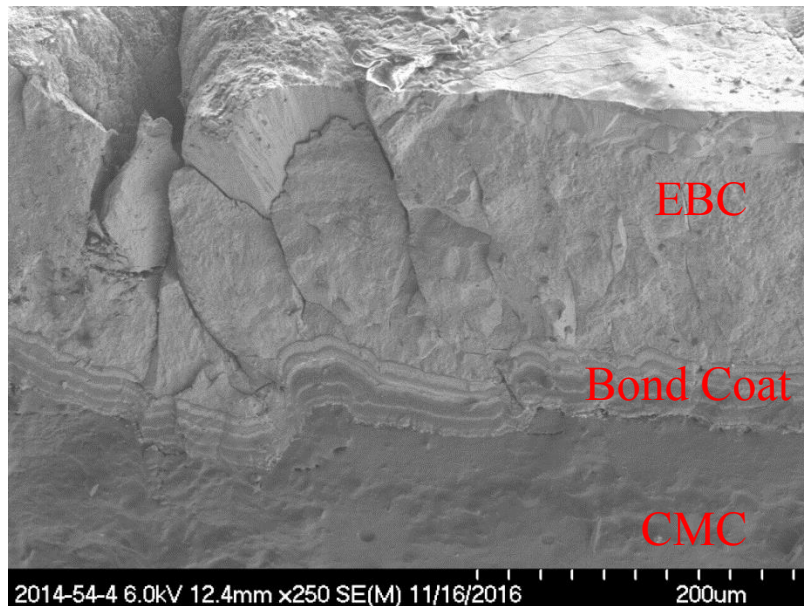
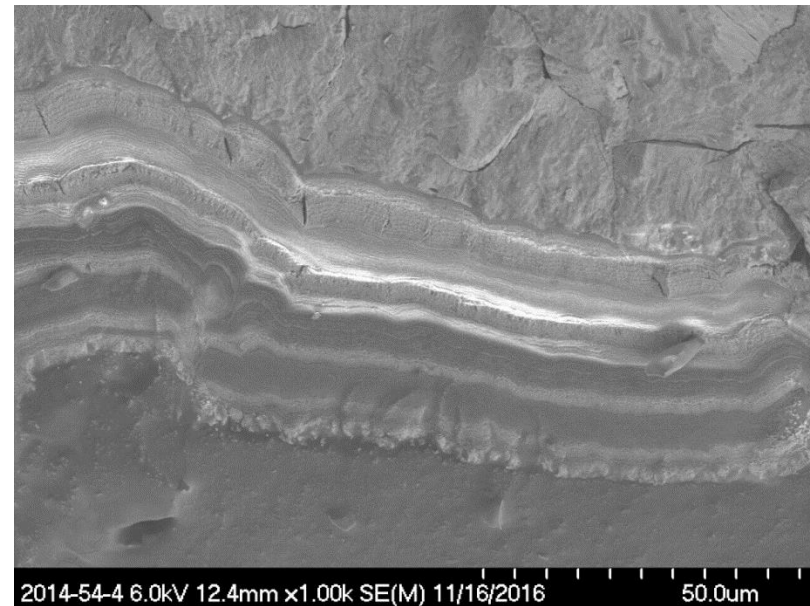
SEM of Fracture Surface after 487 hour Laser SPLCF

- Most of the fiber tows exhibited brittle failure
- Oxygen mapping of the cross-section was planned, but not yet completed
 - We want to know if the bond coat is oxidizing in air, before moving on to steam
 - Regardless, the sample lasted 487 hours
